Manhole Inspection Summary

Manhole # S04EE2021MH

Insp Date: **9/21/06 2:59 PM**

Location Address: **3407 OLYMPIA AVE**

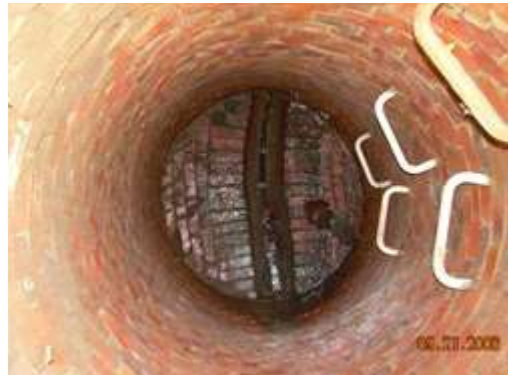
Top View

Corroded steps. Bench debris.

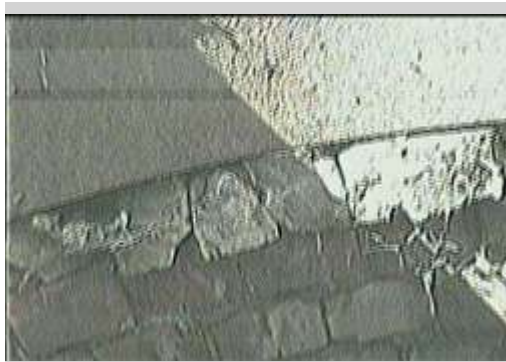
Defect

Frame Offset: **0** (in.) Condition: ☐ Sound ☐ Cracked ☒ **Leaks**

Chimney / Frame Adjustment ☒ Exists Material: **Brick** ☐ Parged Height: **3** (in.)
Condition: ☐ Sound ☒ **Cracked** ☐ Root Intrusion ☒ **Loose Brick** ☒ **Deteriorated**
Infiltration: ☐ None ☒ **Joint** ☒ **Cracks** ☐ Mortar ☐ Roots ☐ Wall

Corbel Material: **Brick** ☐ Parged Type: **Concentric/Eccentric**
Condition: ☐ Sound ☐ Cracked ☐ Root Intrusion ☒ **Loose Brick** ☐ Deteriorated
Infiltration: ☐ None ☐ Joint ☐ Cracks ☒ **Mortar** ☐ Roots ☒ **Wall**

Frame leaks. Adjustment cracks, loose brick and deterioration. Corbel loose brick and infiltration.

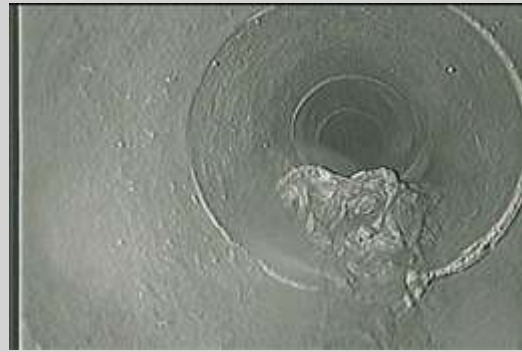
Pipe In @ 5 O'Clock

debris in pipe

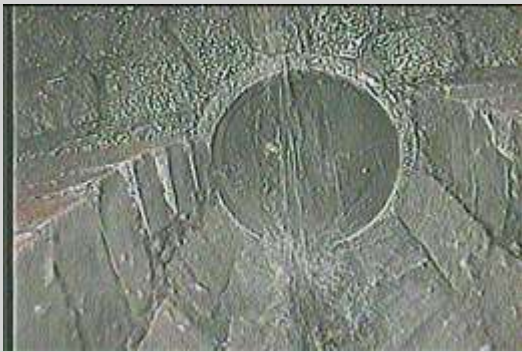
Drop In @ 5 O'Clock

Comments **The I5 Drop Connection picture shows Channel deterioration.**

Channel Material: **Brick** ☐ Parged ☐ Debris (not Condition related)
Channel Exposure: **Fully Open** Junc Dist: **0** nearest .5 ft. Azimuth:
Condition: ☐ Sound ☐ Cracked ☐ Root Intrusion ☒ **Deteriorated** ☐ Leaks ☐ Debris

Drop Condition: **Partly Clogged**
